Planning File: TP-24-13

HOUSE - 24926 Strike Street Veneta, Oregon

CONSULTATION REPORT

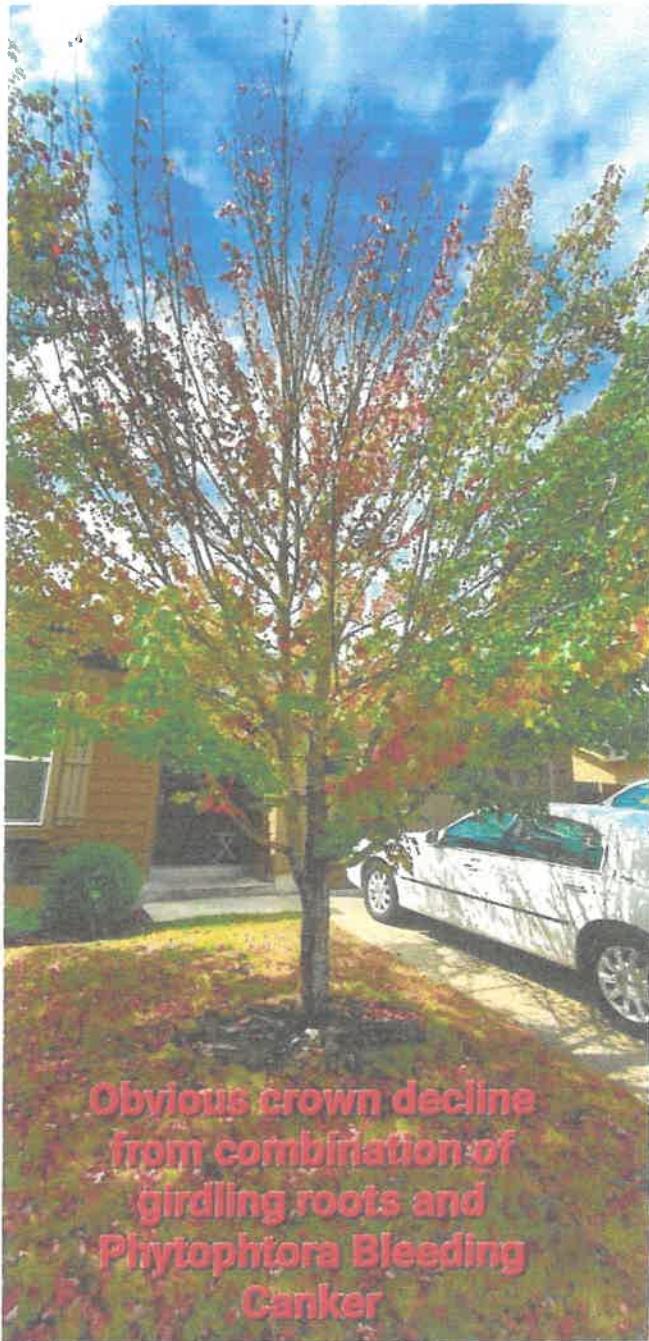
The north tree is showing obvious decline in the form of sparse foliage with early signs of fall color in approx. 50% of the crown. A closer examination of the trunk and lower branches shows exudations of dark sticky liquid and the flare of the trunk (natural widening of the trunk as it meets the main roots) is not visible but rather severely constricted by a network of girdling roots (see pictures in Supporting Materials).

Sandy Bryson's north Red Maple is a perfect example of such tree. The stress from what I describe above has made the tree susceptible to a canker disease called *Phytophthora* (*Phytophthora sp.*), visible in the form of the dark sap exudation. The tight network of girdling roots is only worsening the situation and I strongly believe the tree is bound to die within a couple of years.

**Obvious crown decline
from combination of
girdling roots and
Phytophthora Bleeding
Canker**

I strongly recommend the removal of the north Red Maple in Sandy Bryson's front yard as well as the grinding of its stump. If a new tree is allowed to be planted, the species needs to be well suited for the soil type, space (not enough room for a large shade tree) and climate.
