Planning File: TP-24-13

HOUSE - 24926 Strike Street Veneta, Oregon

CONSULTATION REPORT

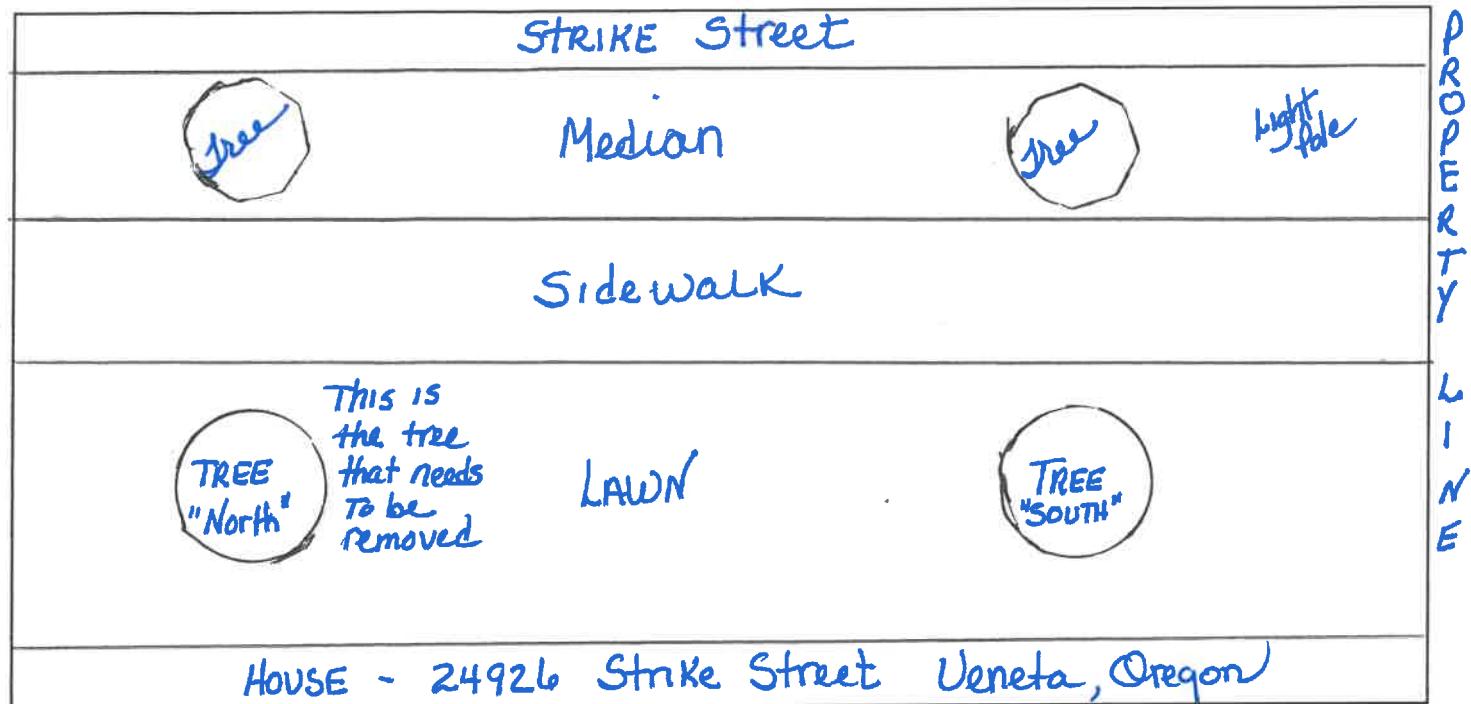
| Tree # | Common Name | Health | DBH or Circ |
|---|---|---|---|
| 1 | <u>Red Maple (Acer rubrum)</u> | <input type="checkbox"/> Good <input checked="" type="checkbox"/> Poor <input checked="" type="checkbox"/> Dead <input checked="" type="checkbox"/> DYING | <u>DBH 16 inches AT NEAREST INCH</u> |

I strongly recommend the removal of the north Red Maple in Sandy Bryson's front yard as well as the grinding of its stump. If a new tree is allowed to be planted, the species needs to be well suited for the soil type, space (not enough room for a large shade tree) and climate.
